## “DEADLY CROSSING: Neglected Bridges and Exploding Oil Trains”

The most complex and vulnerable point on the proposed PVCP route through the city is the rail bridge.

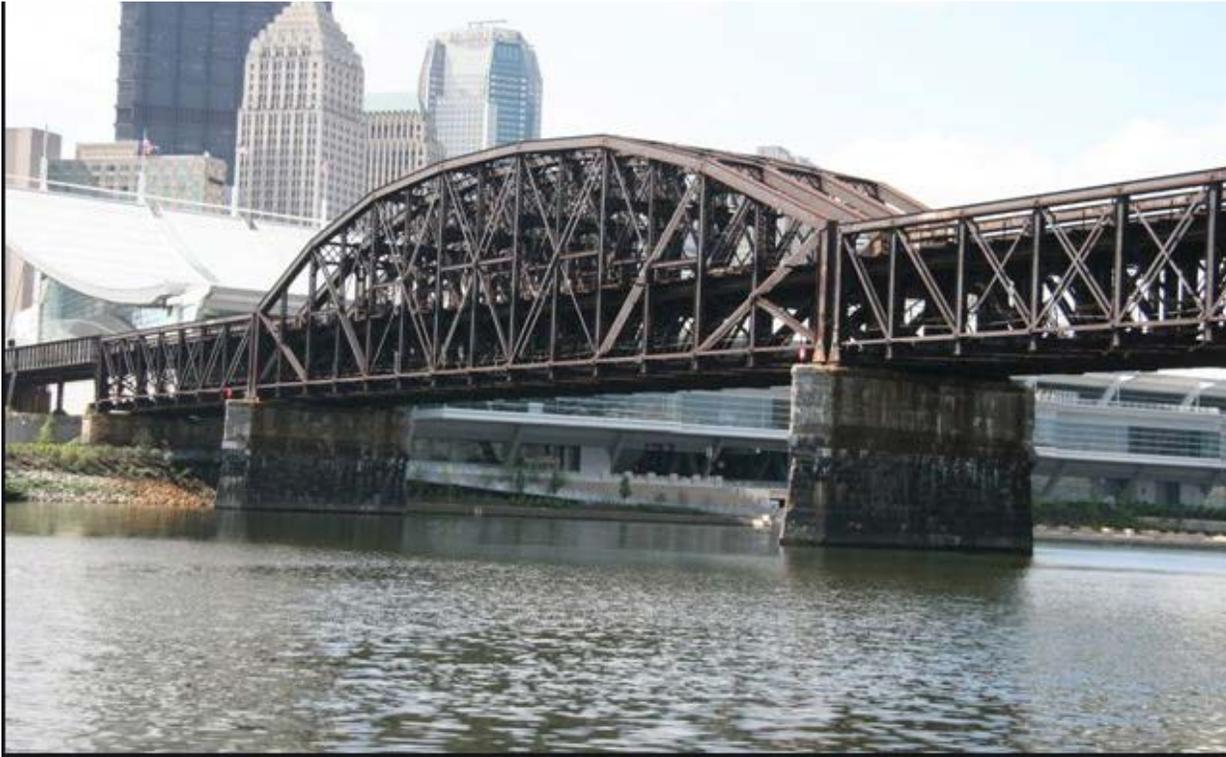
**Ft. Wayne Railroad Bridge next to the David Lawrence Convention Center. Built 1904, there are more than 200,000 people who live and work within the blast zone.**

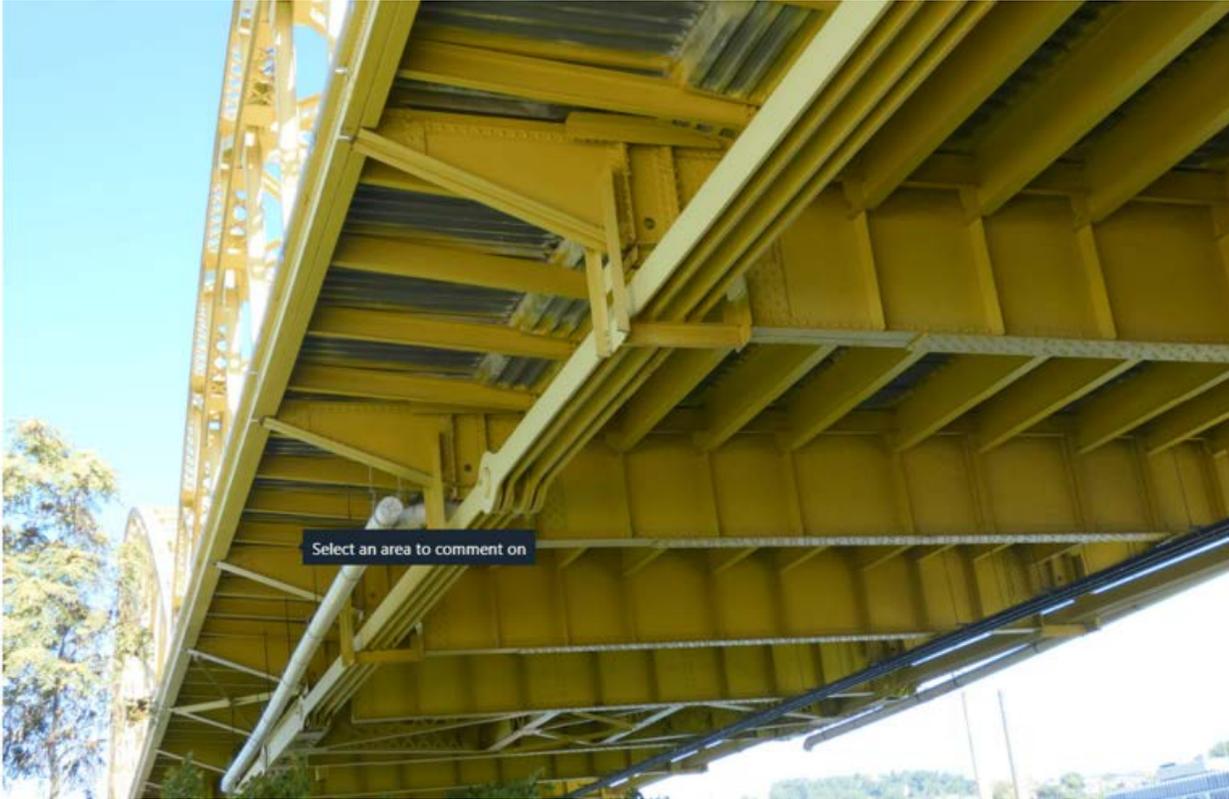
**The David McCullough Bridge,  
commonly known as the 16th Street  
Bridge. Owned by the City; same  
age as the Fort Wayne Bridge.**

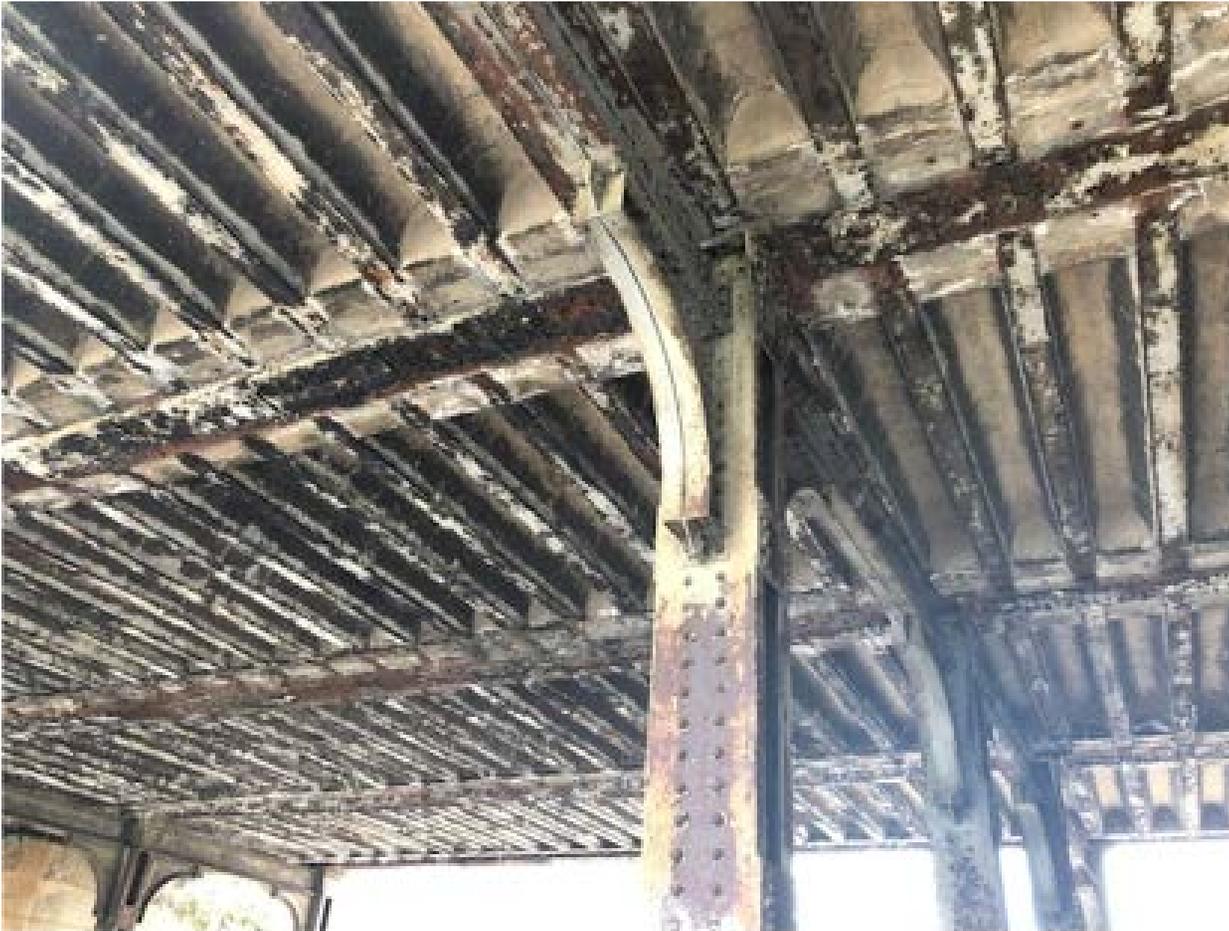
**The 16<sup>th</sup> and Chestnut Street rail bridge. Similar neglect exists throughout the proposed route**

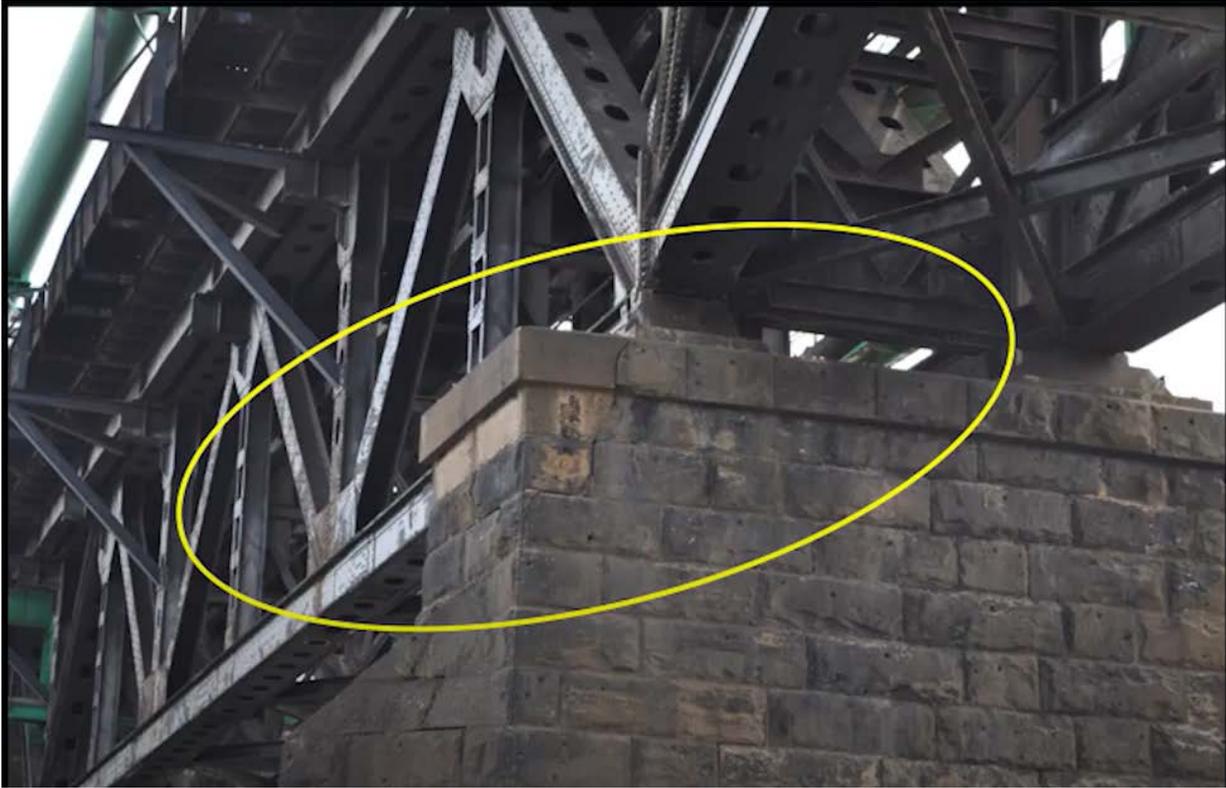
**Union railroad bridge at Mile Marker  
11.5- cracked concrete under  
support beams**

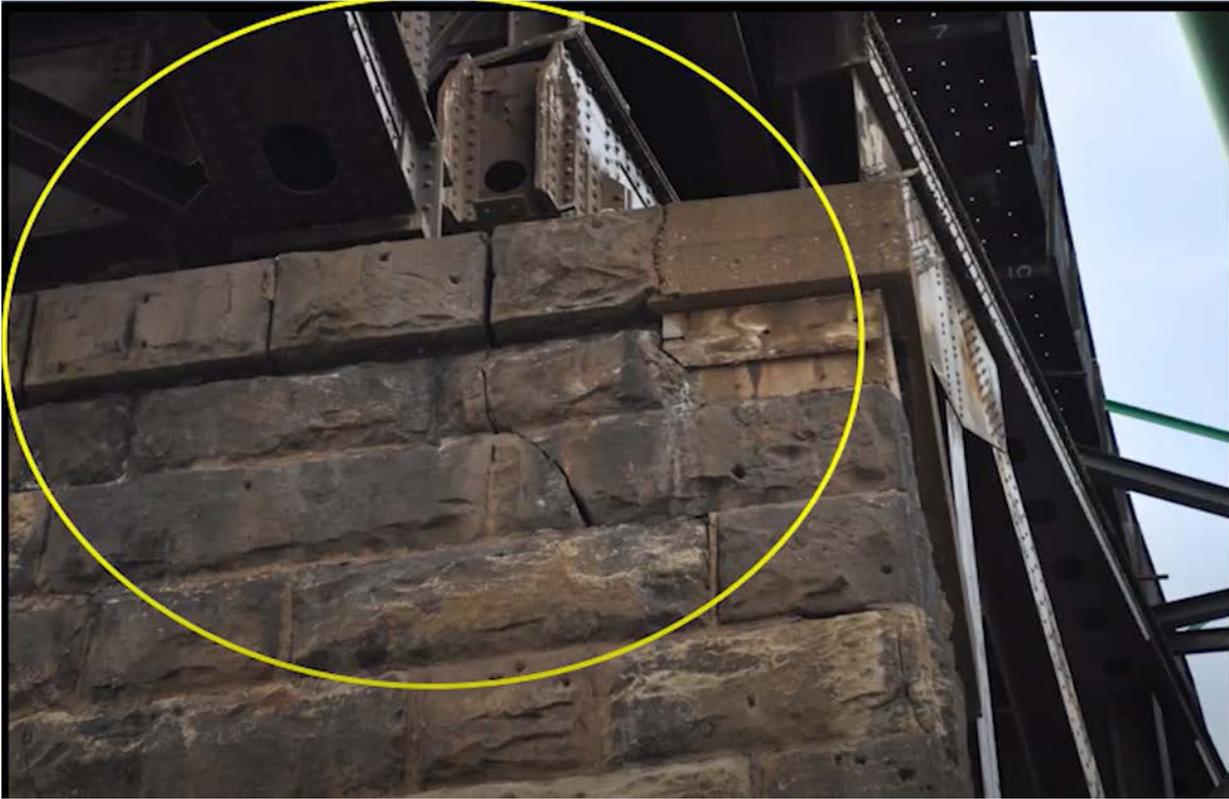
**Union railroad bridge at Mile Marker  
11.5- cracked concrete under  
support beams**

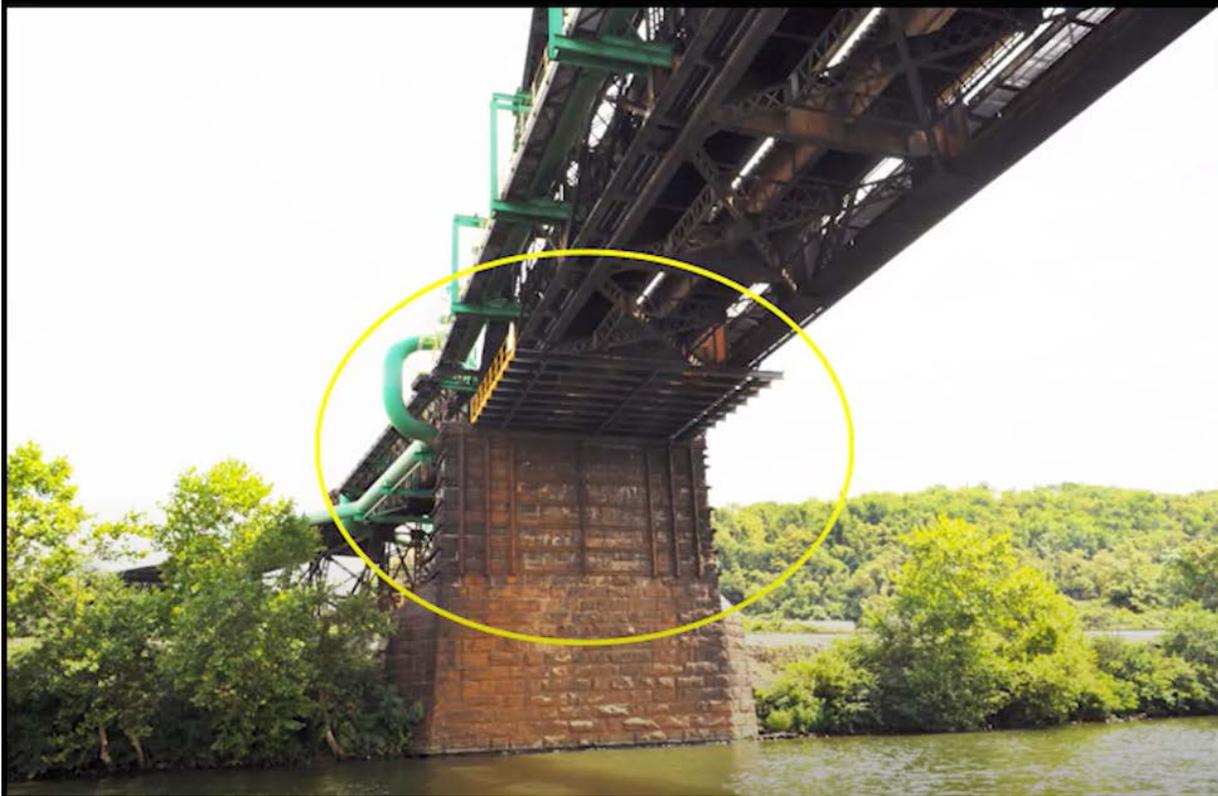
**Union railroad bridge at Mile Marker  
11.5.**

**Pipes on this bridge contain coke gas.**

**Rusting steel reinforcements**

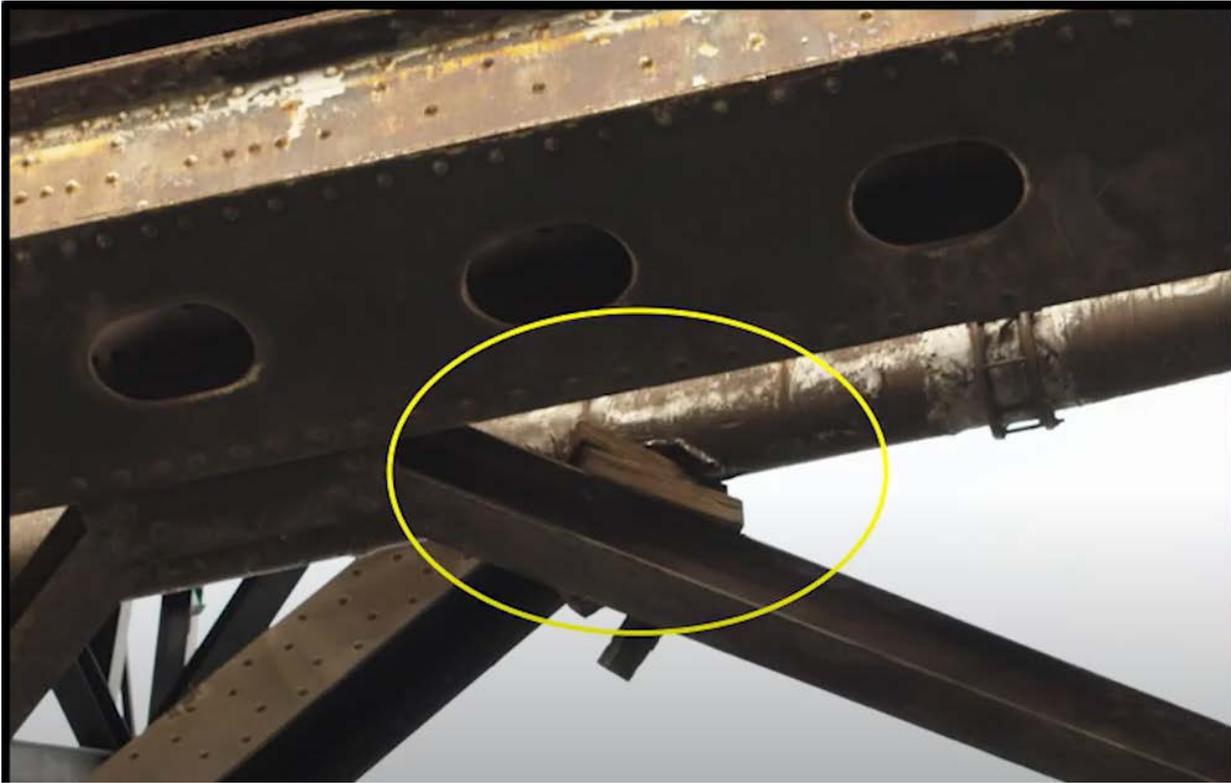
**Union railroad bridge at Mile  
Marker 11.5.**

**Wood support under pipes.**

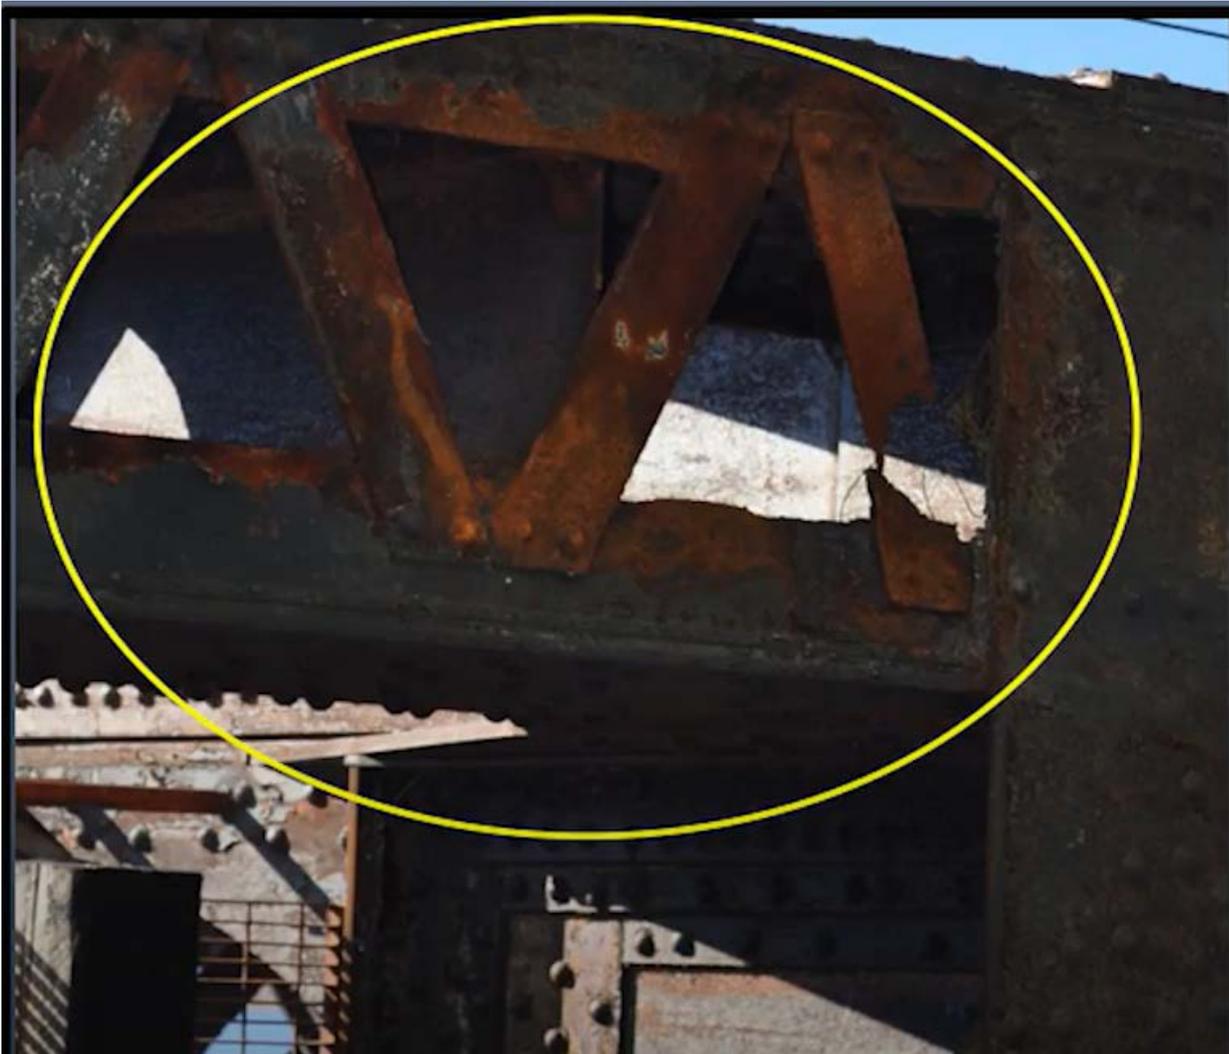
**Union railroad bridge at Mile Marker  
11.5.**

**Completely corroded cross-supports.**

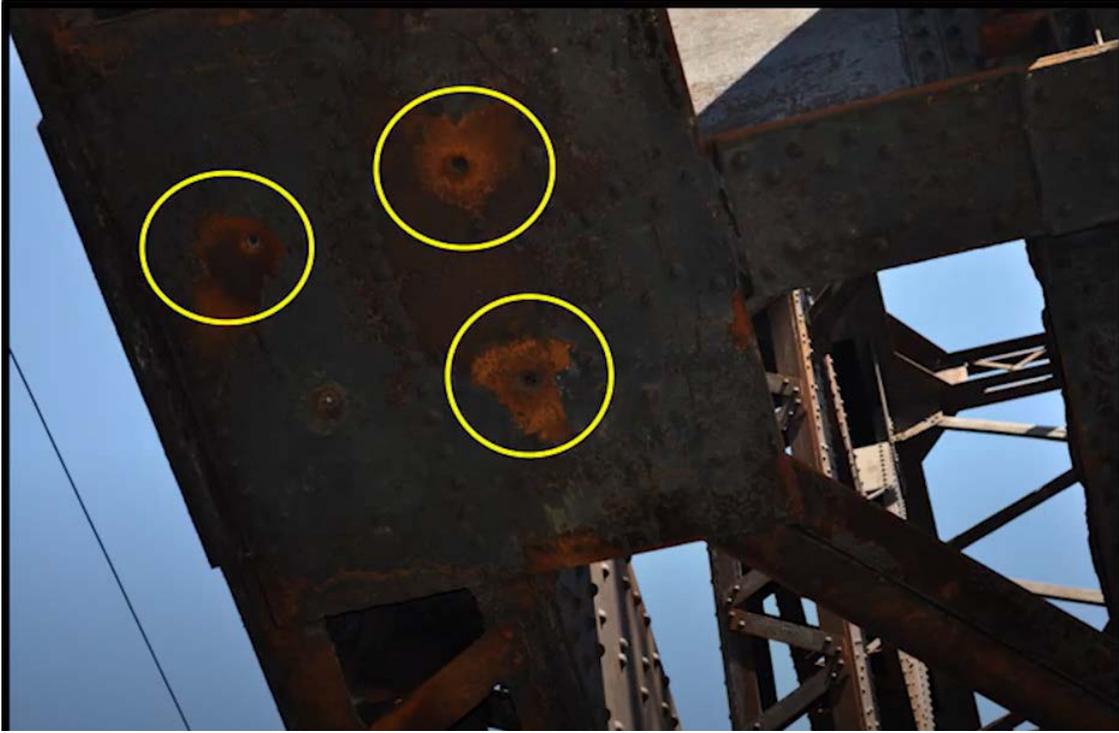
**Union railroad bridge at Mile Marker 11.5.  
Missing bolts**

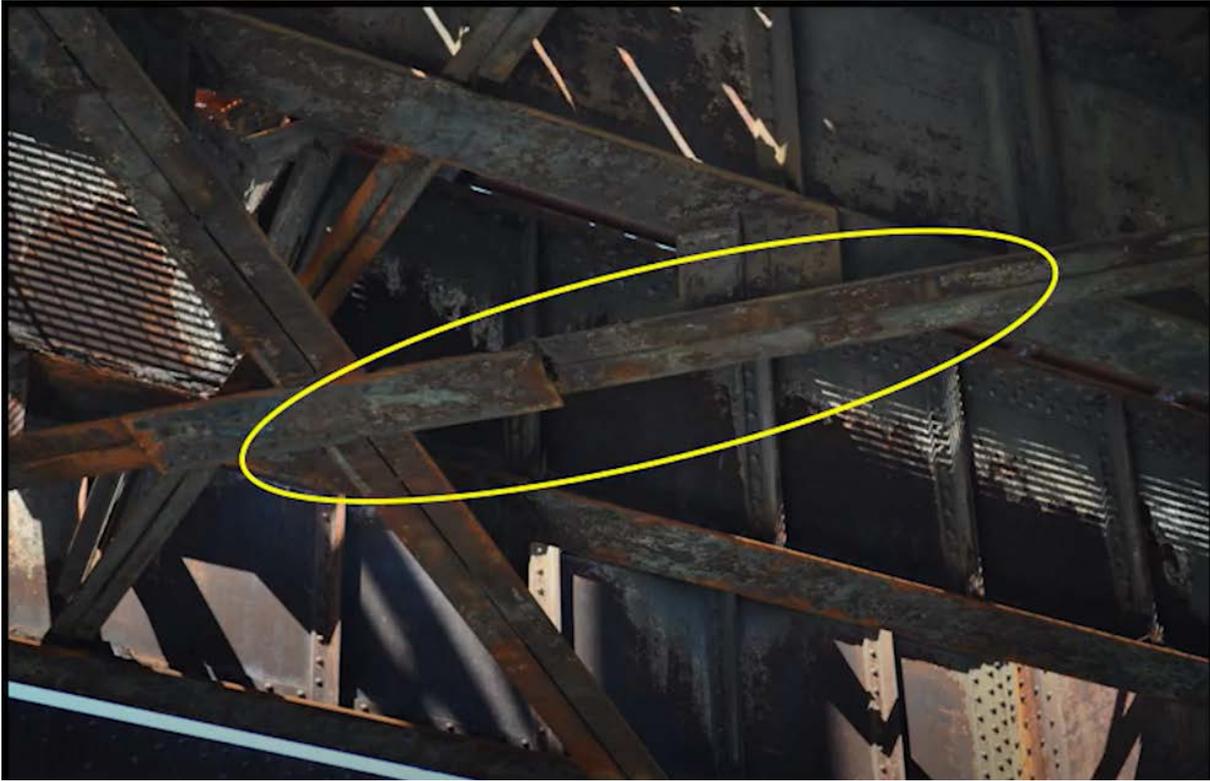
**Union railroad bridge at Mile Marker  
11.5.**

**Completely disconnected pieces**
